# SITE QUALITY REVIEW

**Garraby Mews, Victoria Way,  
Carlisle, CA2 5NP**

<b>Site Reference:</b>	PL-LABC-1959759
<b>Builder:</b>	Smith's Builders plc
<b>Developer:</b>	Rutland Homes Ltd
<b>Site Manager:</b>	John Smith

<b>Auditor:</b>	Mr Antal Poor
<b>Date of Inspection:</b>	02/03/2023
<b>Auditor Email:</b>	antal.poor@mdwis.co.uk
<b>Contact:</b>	07855548362

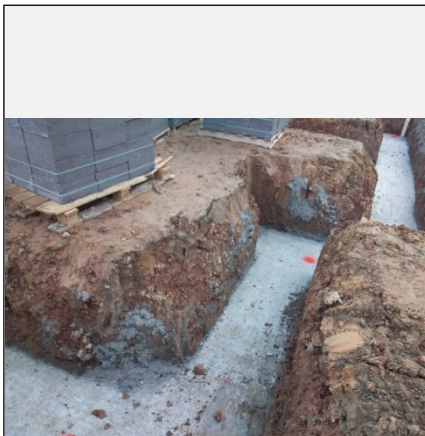
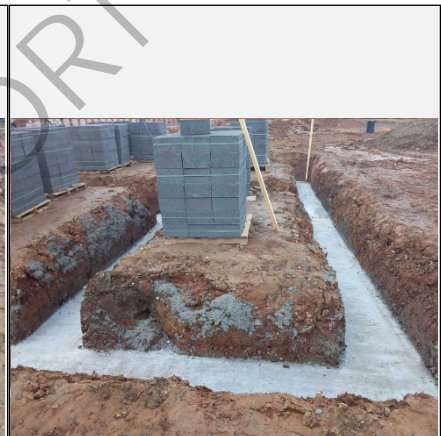
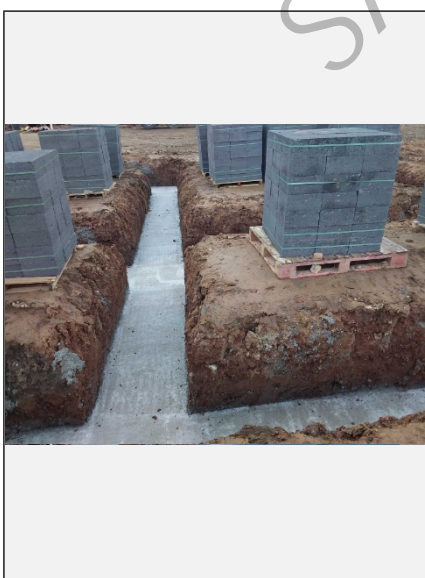
DESCRIPTION	SEVERITY	PLOTS AFFECTED
The strip foundations have been excavated and concreted prior to my inspection. The concrete was generally laid to straight lines and level <b>Images: 1, 2, 3, 4</b>	Industry Standard	Plot 243

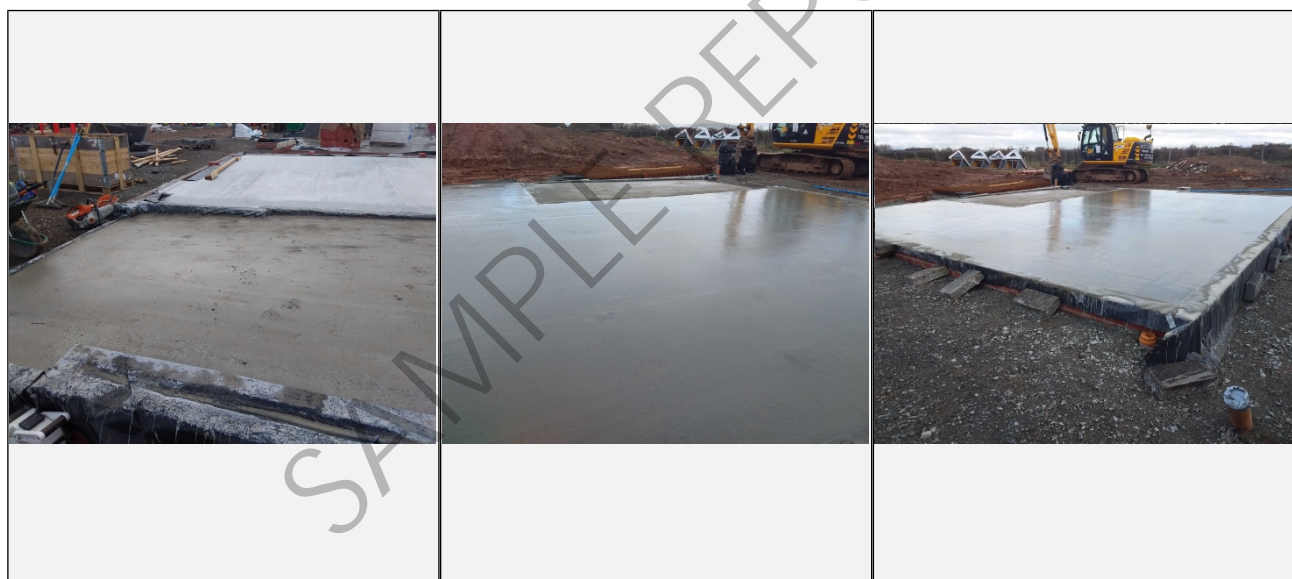
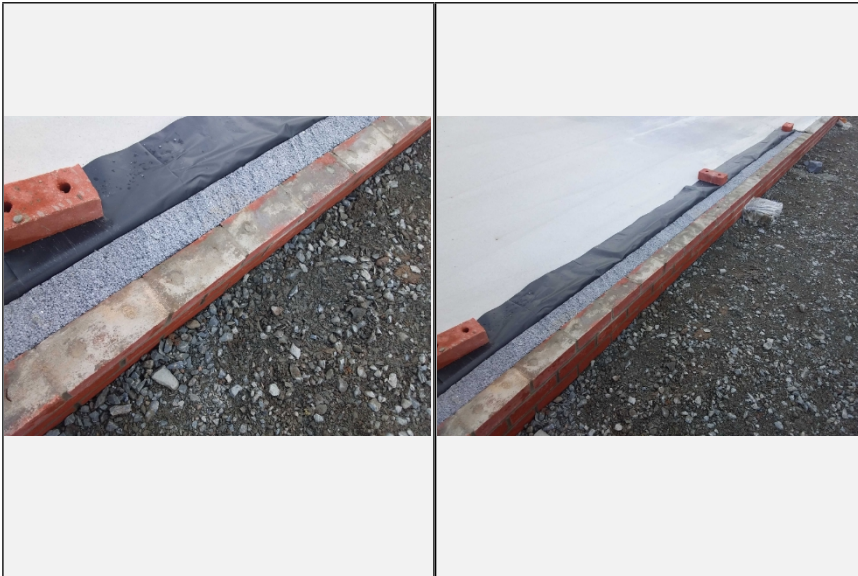
DESCRIPTION	SEVERITY	PLOTS AFFECTED
The garage floor has been concreted with a slight fall to the outside of the property <b>Images: 1</b>	Good Standard	Plot 236
The concrete screed has been freshly poured in a neat and tidy manner <b>Images: 2, 3</b>	Industry Standard	Plot 235
Insulated upstands are visible to the underside of the DPM to prevent cold bridging and the frogs have all been concreted <b>Images: 4, 5</b>	Industry Standard	Plot 236

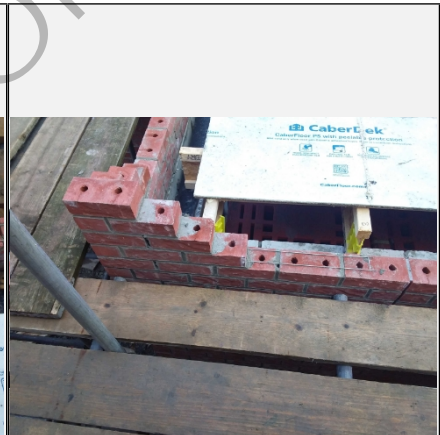
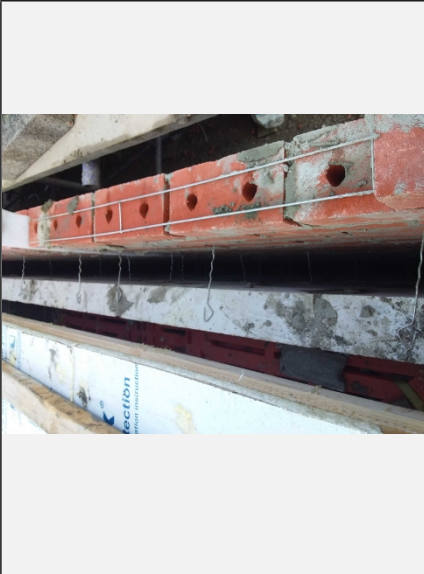
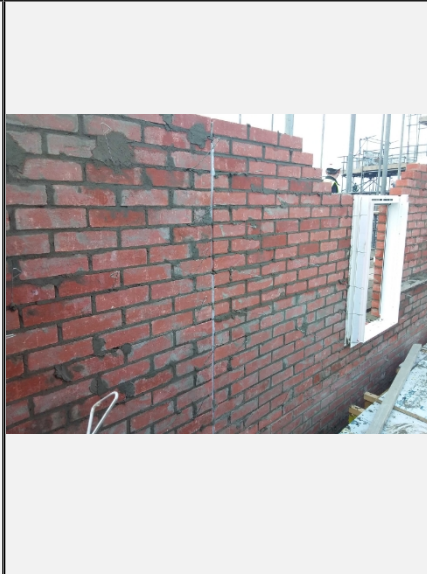
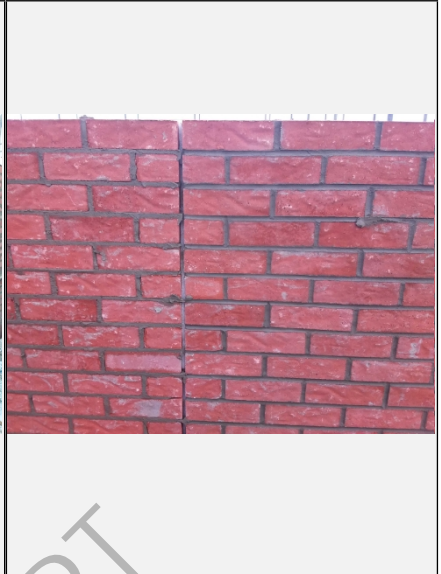
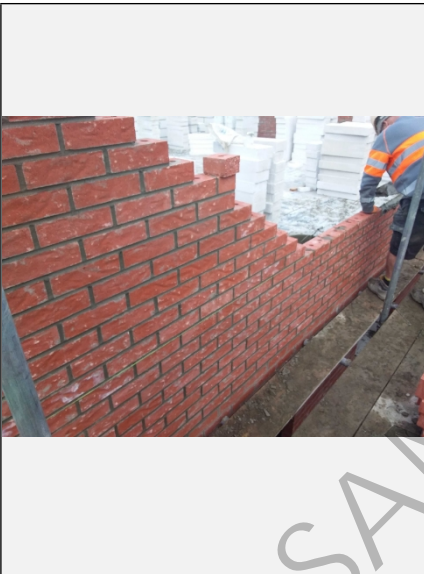
DESCRIPTION	SEVERITY	PLOTS AFFECTED
Reinforcement is being installed to the brickwork as per design <b>Images: 1, 2, 3, 4</b>	Industry Standard	Plot 258 - Plot 259
The external leaf walling has been constructed using Persimmon Gen3 concrete bricks. The perpendicular and longitudinal joints are generally uniform and have good alignment and shape corners <b>Images: 5, 6, 7</b>	Industry Standard	Plot 258

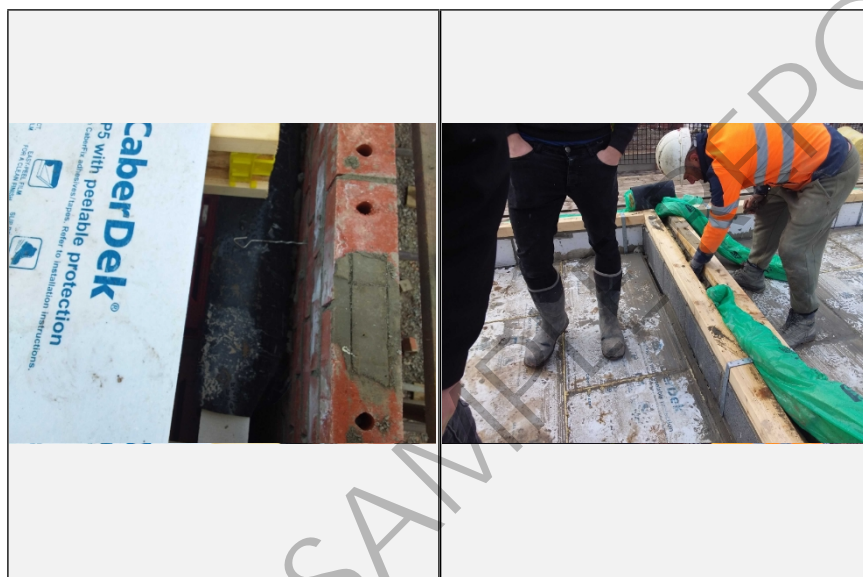
DESCRIPTION	SEVERITY	PLOTS AFFECTED
Cavity trays have been installed correctly, turned up at the ends with weepholes in place <b>Images: 1</b>	Industry Standard	Plot 259
Under the instruction of the Site Manager the bricklaying contractor returned to the plot to clean the party wall cavity <b>Images: 2</b>	Industry Standard	Plot 256

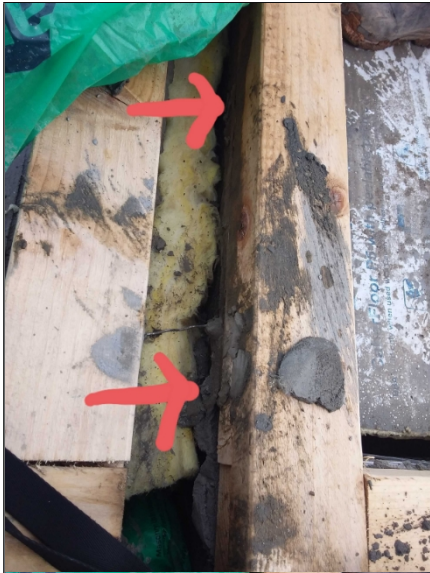
1) Plot 256 -

DESCRIPTION	SEVERITY	PLOTS AFFECTED
<p>Cavity to party wall had mortar present upon the accoustic insulation. The site manager instructed the brickwork contractor to clean immediately</p> <p><b>Images: 1</b></p>	Poor - Risk of Claim	Plot 256

Maintain clear cavities to party walls to prevent sound transference and adhere to the Robust detail requirement.

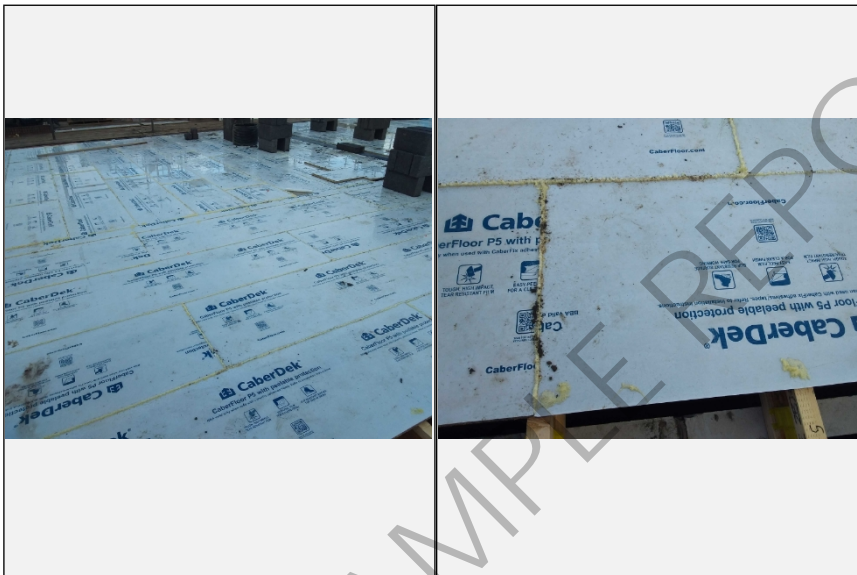
DESCRIPTION	SEVERITY	PLOTS AFFECTED
Caberdek floorboards have been installed with all joints and mechanically fixing points glued using Caberfix D4 glue <b>Images: 1, 2</b>	Industry Standard	Plot 259

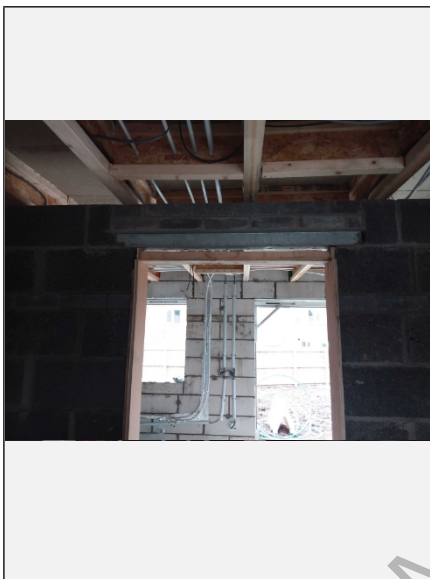
1) Plot 261 -

DESCRIPTION	SEVERITY	PLOTS AFFECTED
Internal lintels have been installed upon full blocks with 150mm bearing <b>Images: 1</b>	Industry Standard	Plot 261

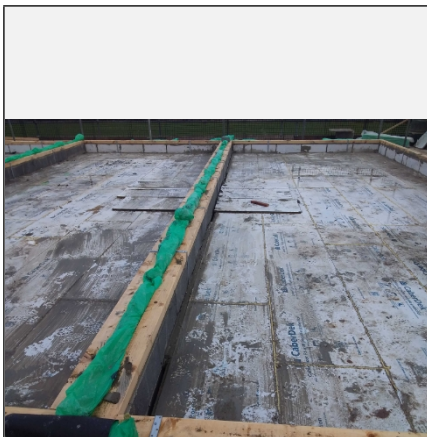
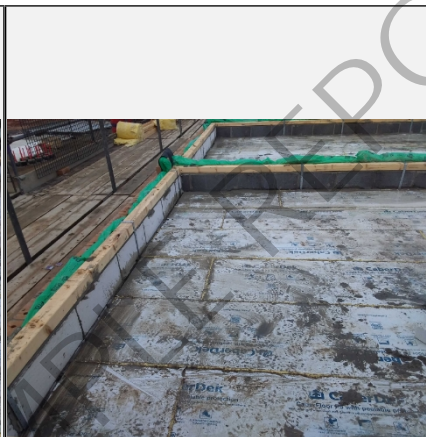
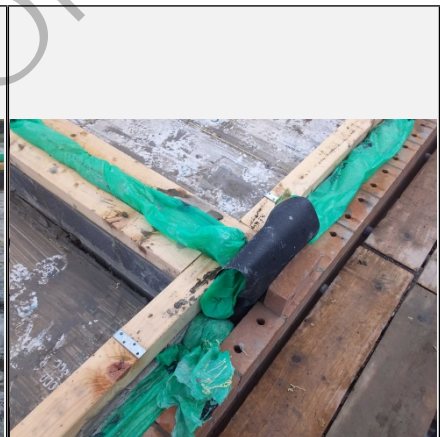
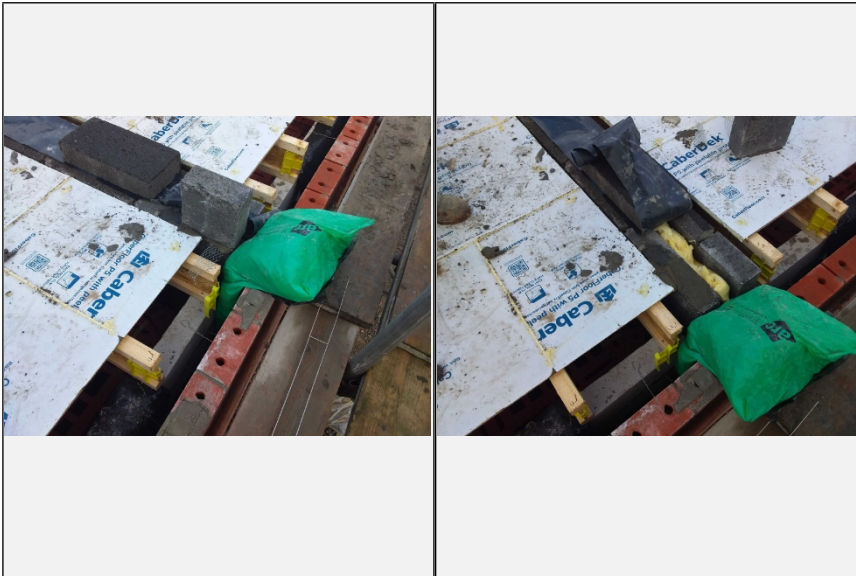
DESCRIPTION	SEVERITY	PLOTS AFFECTED
Fire stopping is in place closing all cavities awaiting the spandrel installation <b>Images: 1, 2, 3</b>	Industry Standard	Plot 256
The partywalls have been filled using accoustic insulation with 300mm fire socks in place to the party wall junctions <b>Images: 4, 5</b>	Industry Standard	Plot 259

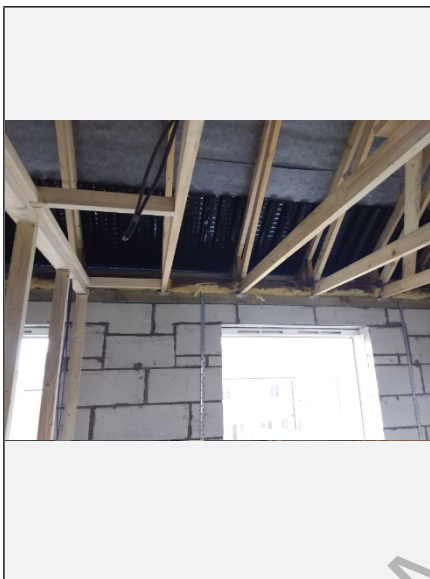
1) Plot 261 -

DESCRIPTION	SEVERITY	PLOTS AFFECTED
Eaves ventilation has been installed to the roof space <b>Images: 1</b>	Industry Standard	Plot 261

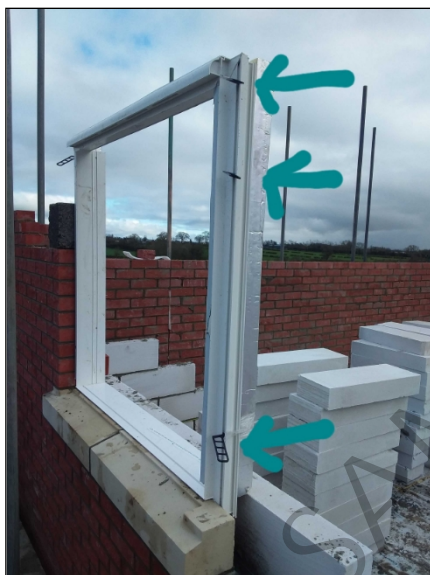
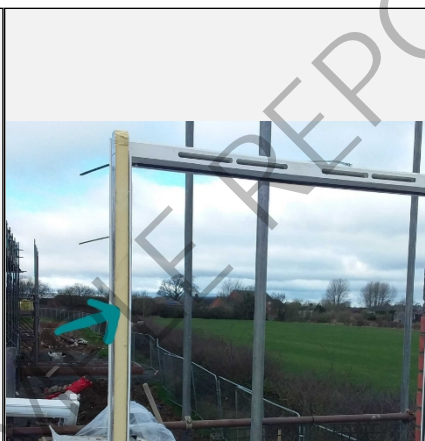
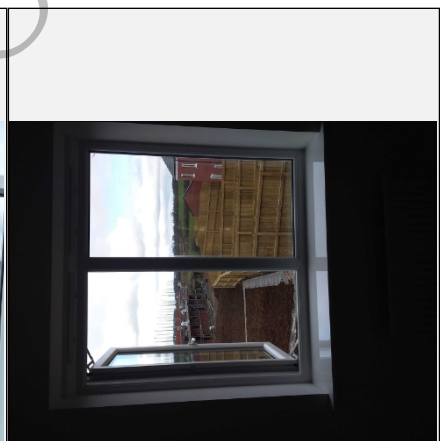
DESCRIPTION	SEVERITY	PLOTS AFFECTED
The UPVC window formers have been installed with ties to securely connect to the brickwork with added insulation to the reveals to prevent any chance of cold bridging. <b>Images: 1, 2</b>	Industry Standard	Plot 258
Means of escape windows have been installed to every first floor habitable rooms, within this 2 storey detached plot <b>Images: 3</b>	Industry Standard	Plot 265

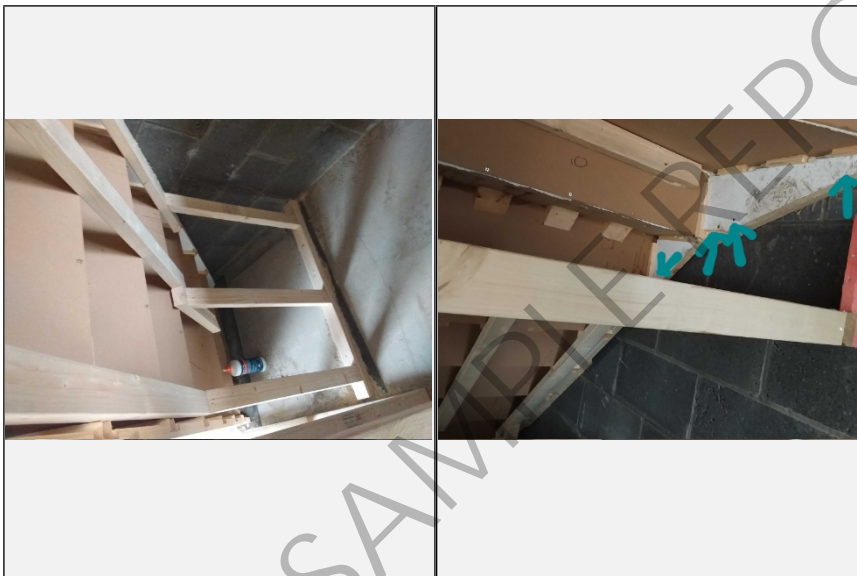
DESCRIPTION	SEVERITY	PLOTS AFFECTED
Propping to the underside of the manufactured timber staircase has been installed upon DPC <b>Images: 1</b>	Industry Standard	Plot 261
The manufactured timber staircase has been affixed to the wall at approx 30mm c/c through a timber bearer <b>Images: 2</b>	Industry Standard	Plot 261

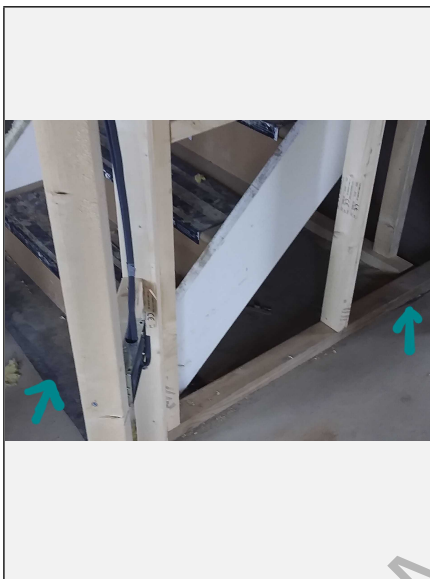
1) Plot 261 -

DESCRIPTION	SEVERITY	PLOTS AFFECTED
All timber studwork to the ground floor has been installed upon DPC <b>Images: 1</b>	Industry Standard	Plot 261

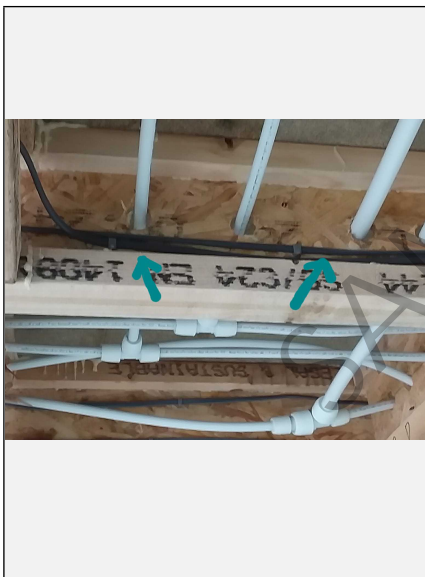
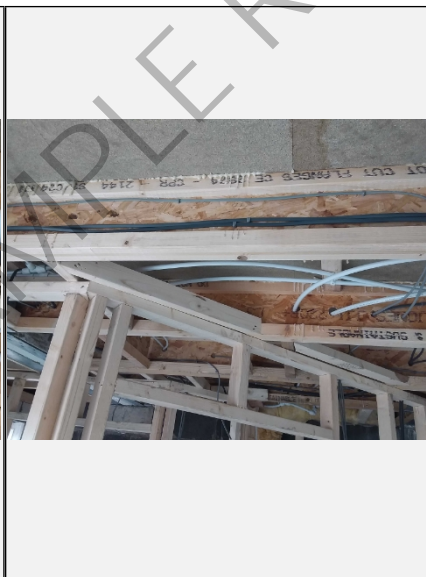
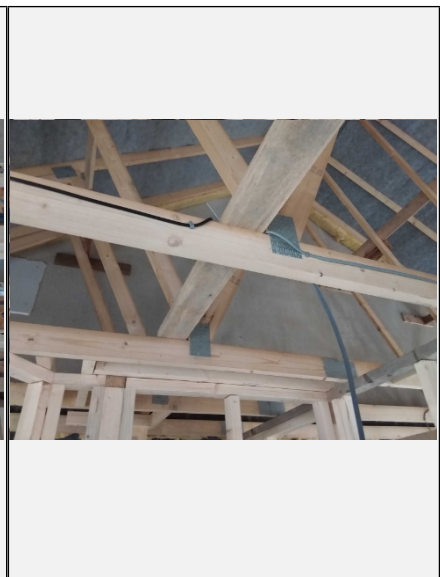
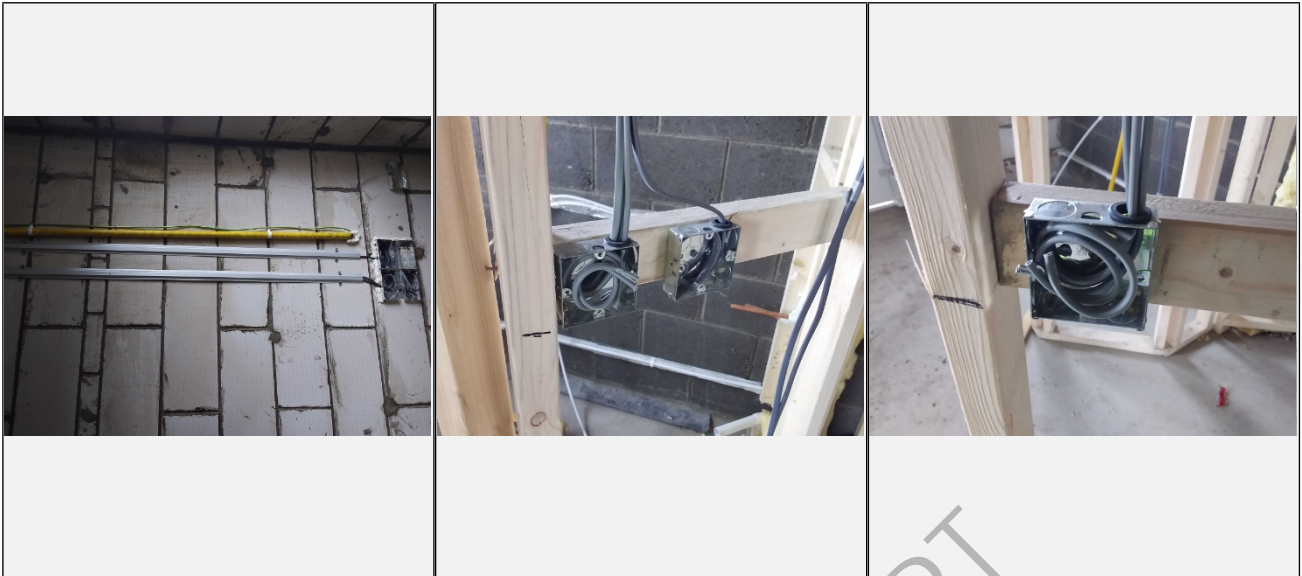
DESCRIPTION	SEVERITY	PLOTS AFFECTED
Wiring has been neatly clipped to the engineered I-joists and the drill holes for wiring to pass through have been carried out to the manufacturer's requirements <b>Images: 1, 2</b>	Industry Standard	Plot 261
Wiring has been installed 50mm above the underside of the trusses to prevent any chance of damage when plasterboarding <b>Images: 3</b>	Industry Standard	Plot 261
Wiring is running within the correct zones as stated within Approved Document P and have metal protective trunking where they run down solid walls <b>Images: 4</b>	Industry Standard	Plot 261
Grommets are in place to the majority of metal socket backboxes <b>Images: 5, 6</b>	Industry Standard	Plot 261

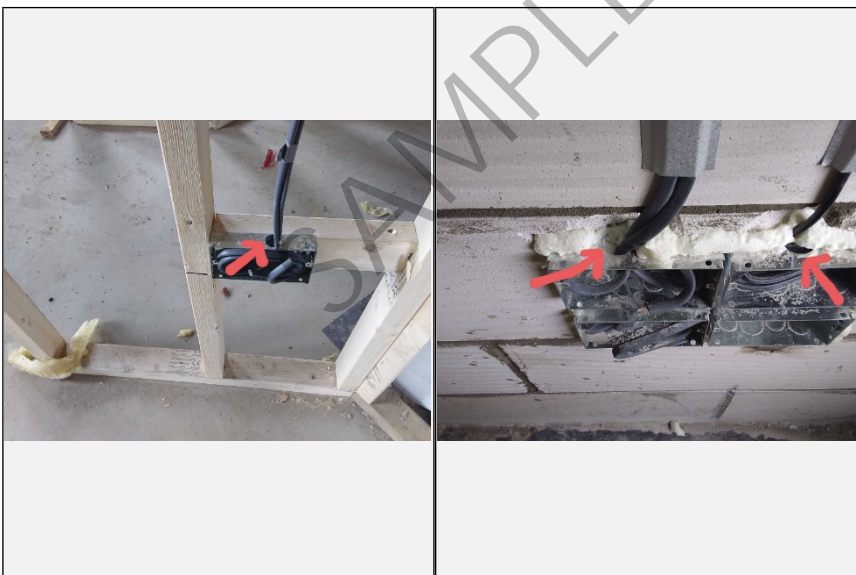
DESCRIPTION	SEVERITY	PLOTS AFFECTED
Missing grommits to a small number of the metal socket backboxes where wiring transfers through <b>Images: 1, 2</b>	Major Non Compliance	Plot 265

The electrician is to fit rubber grommits to all metal socket backboxes.

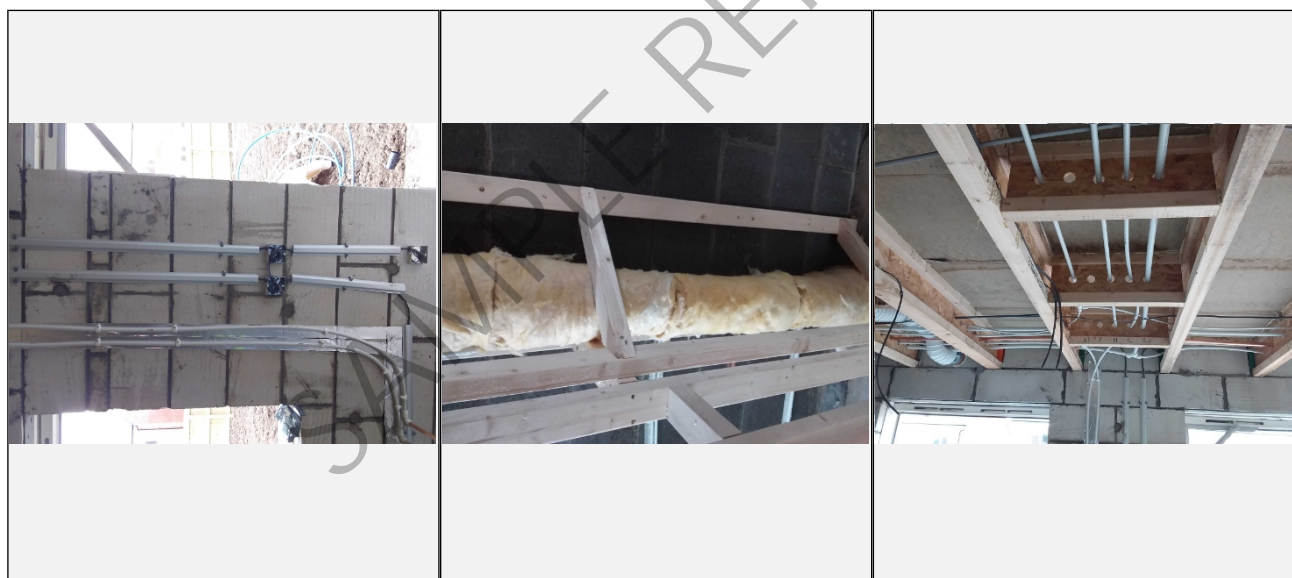
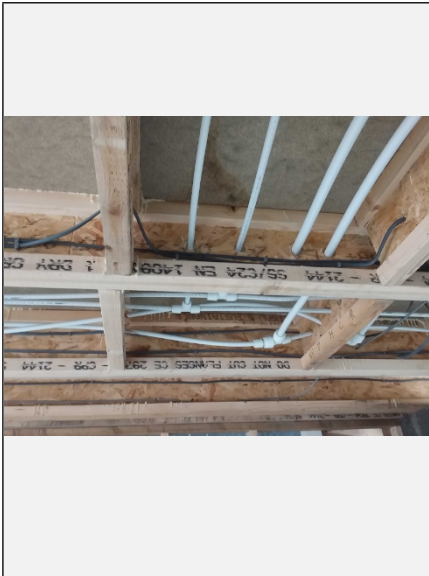
DESCRIPTION	SEVERITY	PLOTS AFFECTED
Pipe runs located upon solid walls have been installed upon foil backing tape for detection purposes <b>Images: 1</b>	Industry Standard	Plot 261
The internal soil stack has been wrapped fully around using insulation for accoustic purposes. To improve please consider using tie wraps or similar to secure in place <b>Images: 2</b>	Industry Standard	Plot 261
The drill holes for pipework to pass through have been carried out to the manufacturer's requirements. Off cuts of joists have been used as noggins to support the pipework between joists <b>Images: 3, 4</b>	Industry Standard	Plot 261

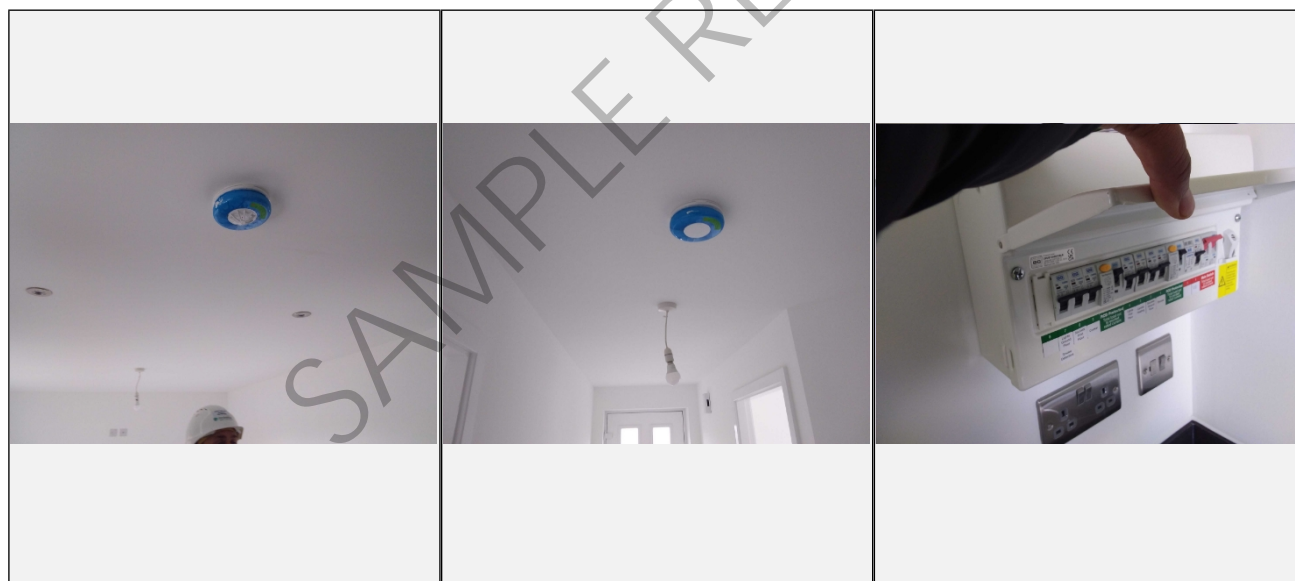
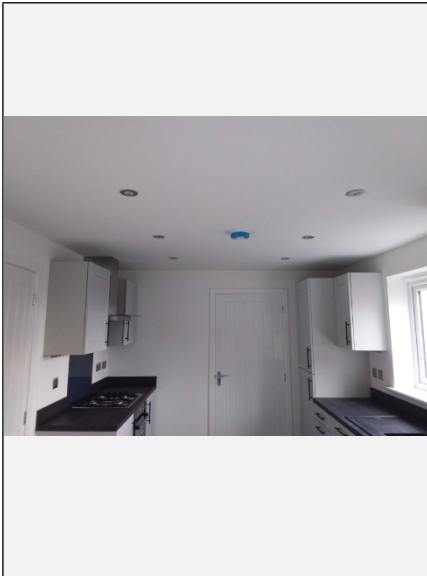
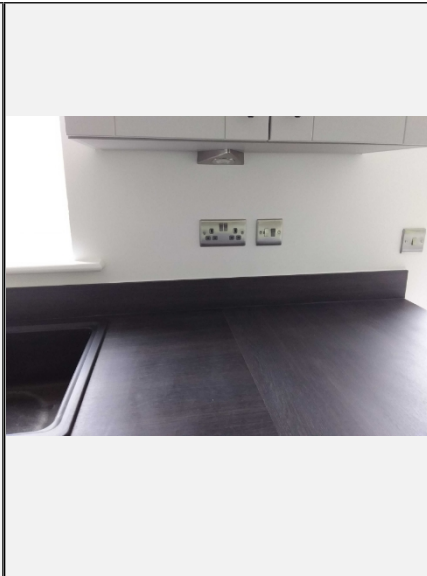
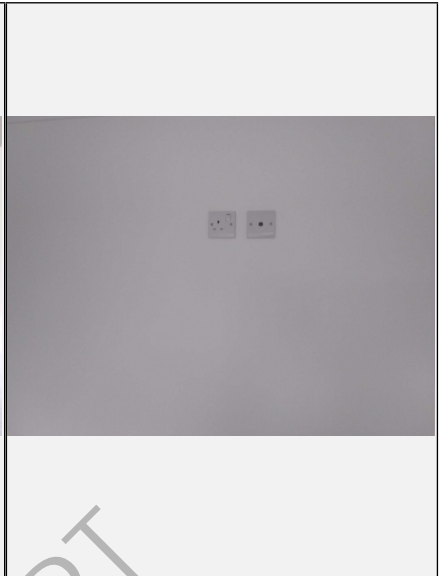
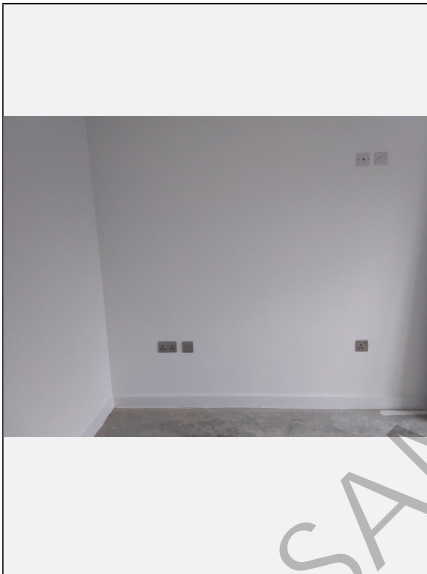
DESCRIPTION	SEVERITY	PLOTS AFFECTED
Mains wired interlinked smoke detection has been positioned correctly within each room and landing areas along with a heat detector to the kitchen, above and beyond the current regulations <b>Images: 1, 2</b>	Good Standard	Plot 265
The consumer unit was fully labelled and marked up with no blank plates missing and set to the correct height as stated within Approved Document P <b>Images: 3</b>	Industry Standard	Plot 265
Good alignment of spotlights to the kitchen ceiling <b>Images: 4</b>	Industry Standard	Plot 265
Good alignment of adjacent sockets for aesthetical purposes <b>Images: 5, 6, 7</b>	Industry Standard	Plot 265

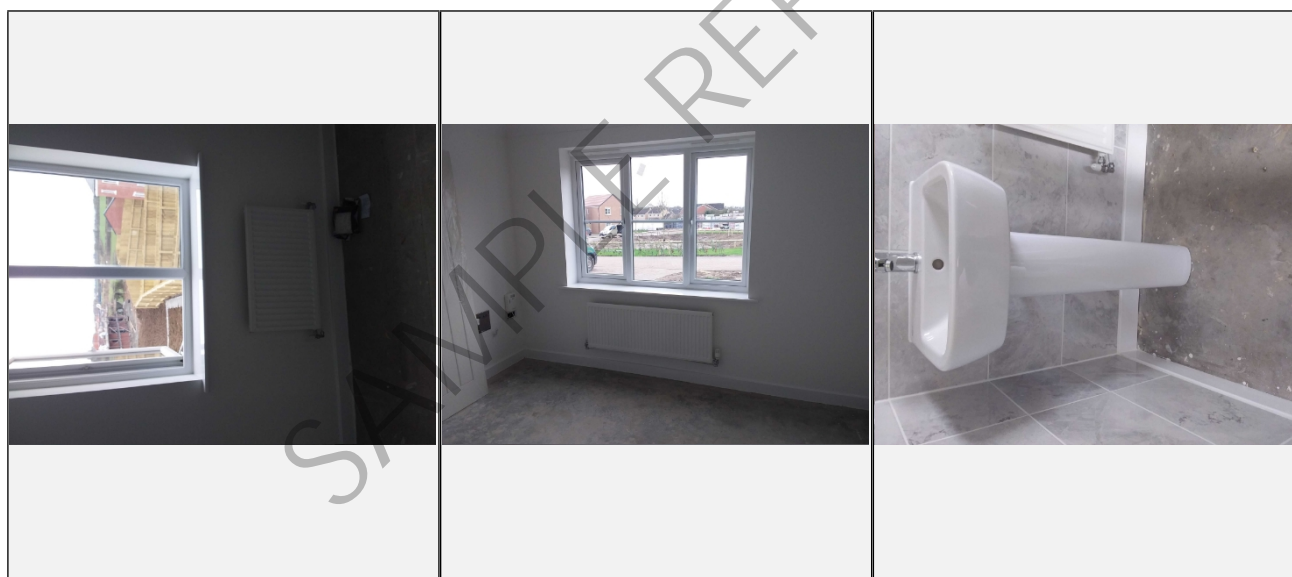
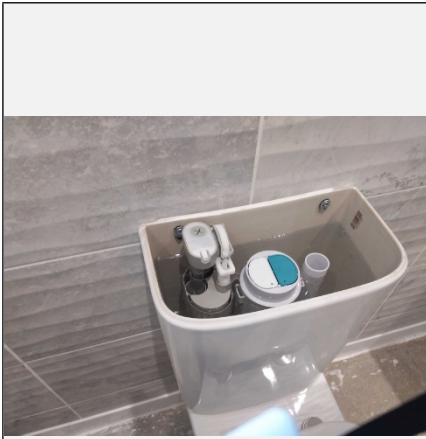
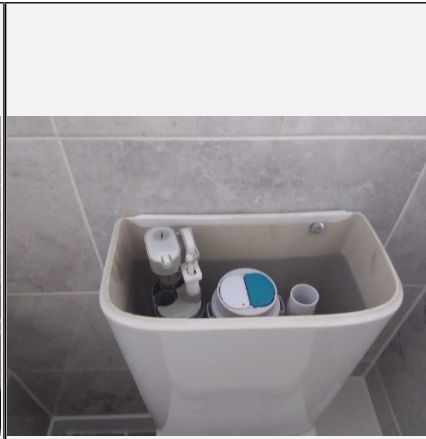
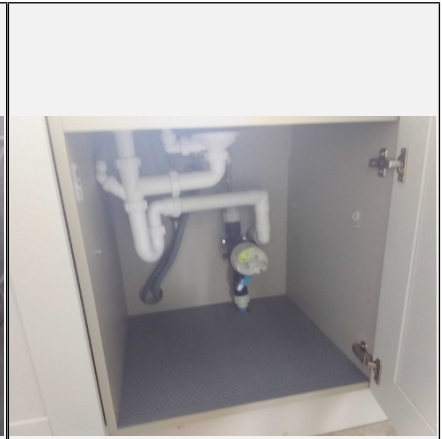
DESCRIPTION	SEVERITY	PLOTS AFFECTED
Radiators have generally been installed plumb and level and centred beneath the windows where possible <b>Images: 1, 2</b>	Industry Standard	Plot 265
WC pans and cisterns have been secured in place using the correct fixings and washers. The pipework behind the washbasins have been neatly concealed behind the pedestals <b>Images: 3, 4, 5</b>	Industry Standard	Plot 265
The pipework under the kitchen sink was neatly installed and the stop-cock was accessible <b>Images: 6</b>	Industry Standard	Plot 265

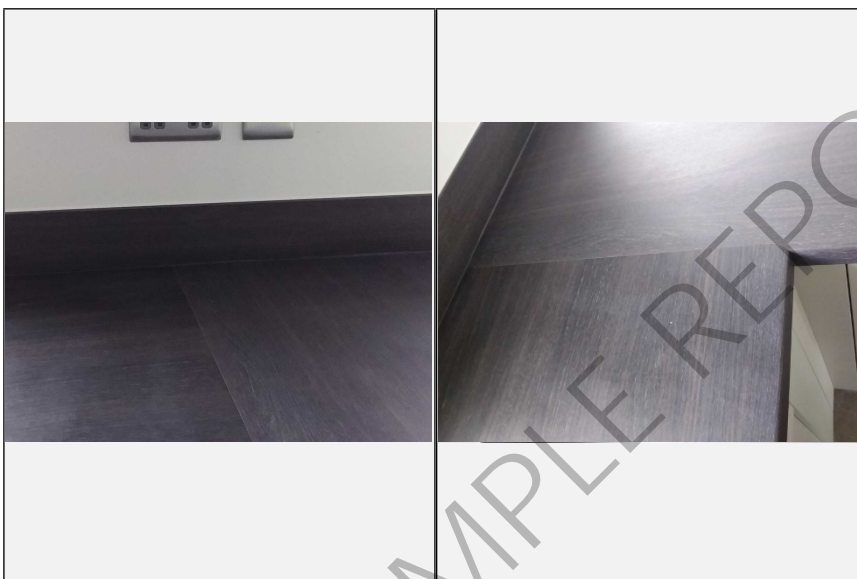
DESCRIPTION	SEVERITY	PLOTS AFFECTED
Worktops and splashbacks were fitted level with tight and smooth joints <b>Images: 1, 2</b>	Industry Standard	Plot 265

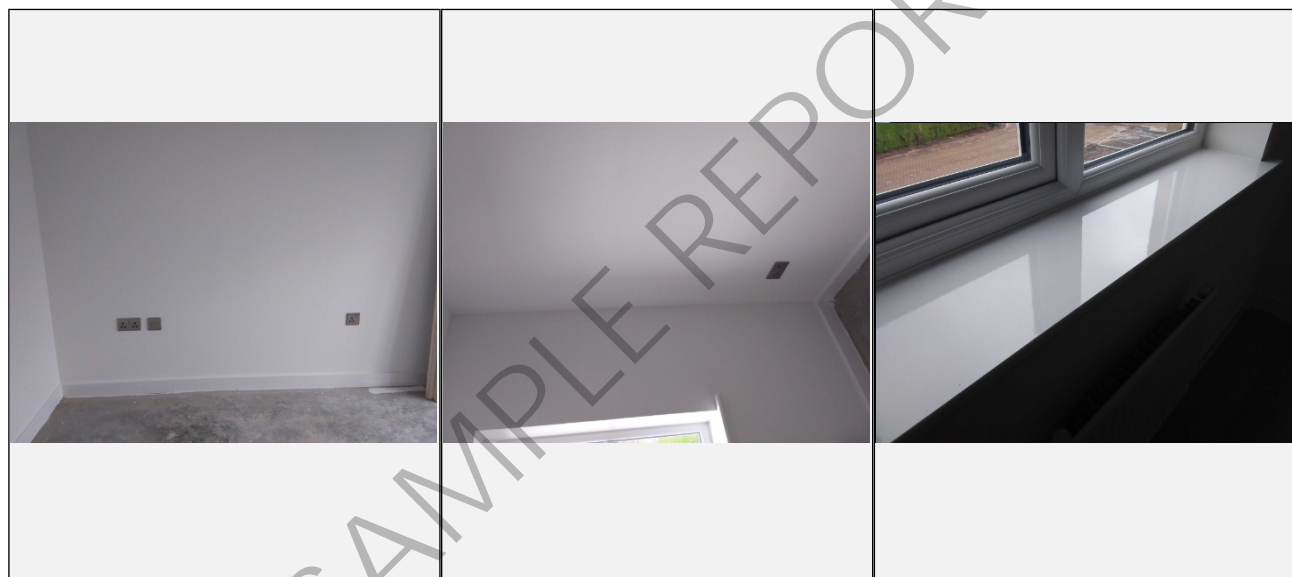
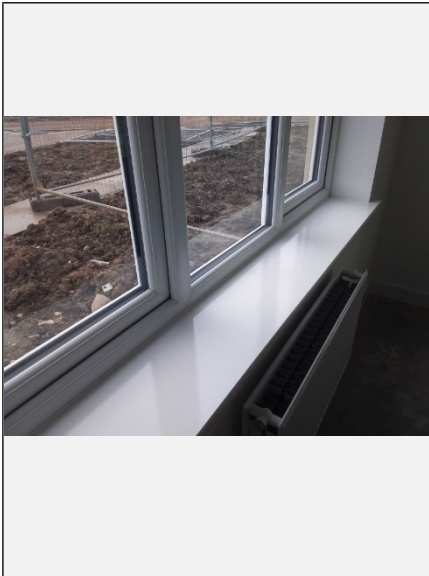
DESCRIPTION	SEVERITY	PLOTS AFFECTED
The emulsion to the walls was to a smooth and consistent finish with good lines to corners at all areas viewed <b>Images: 1, 2</b>	Industry Standard	Plot 265
The gloss work was generally smooth and even <b>Images: 3, 4</b>	Industry Standard	Plot 265

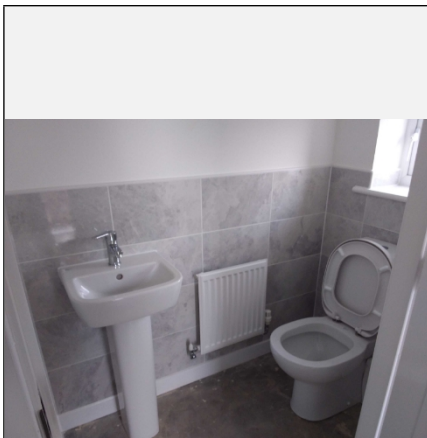
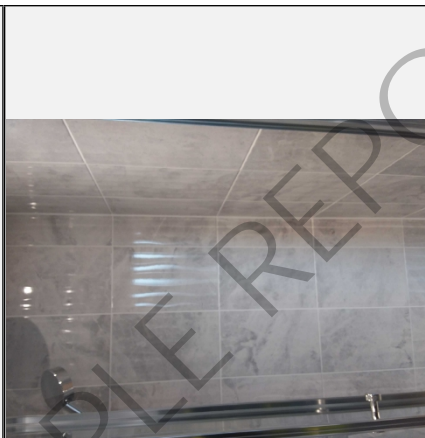
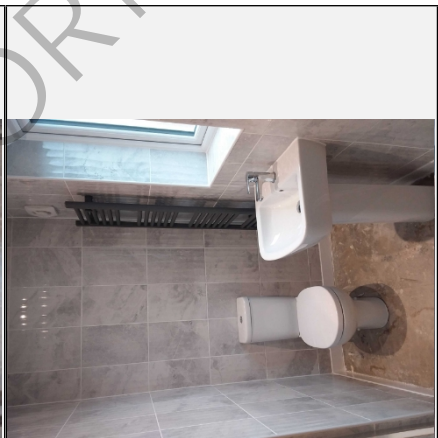
DESCRIPTION	SEVERITY	PLOTS AFFECTED
The ceramic wall tiling was set out for even cuts and smooth and free of lipping. The edge trims were neatly cut and formed at all corners and edges and smoothly grouted. <b>Images: 1, 2, 3</b>	Industry Standard	Plot 265

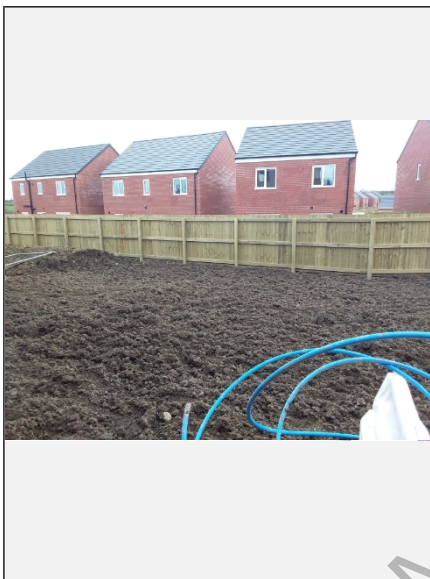
1) Plot 261 -

DESCRIPTION	SEVERITY	PLOTS AFFECTED
The perimeter fencing was fitted to line and level <b>Images: 1</b>	Industry Standard	Plot 261

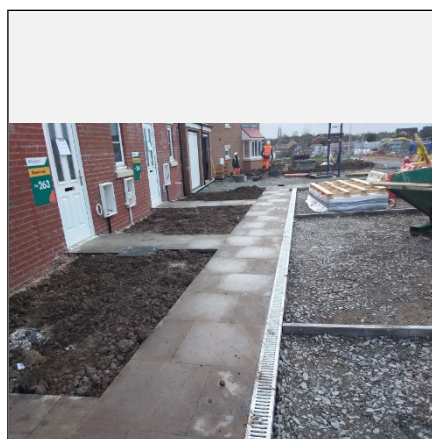
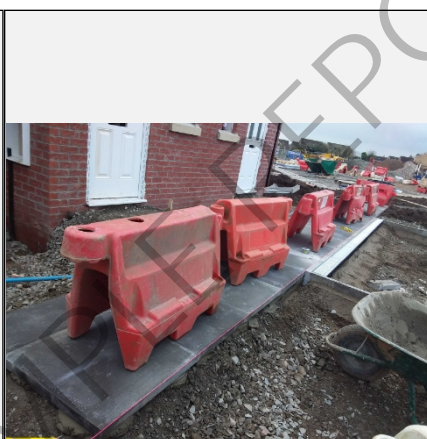
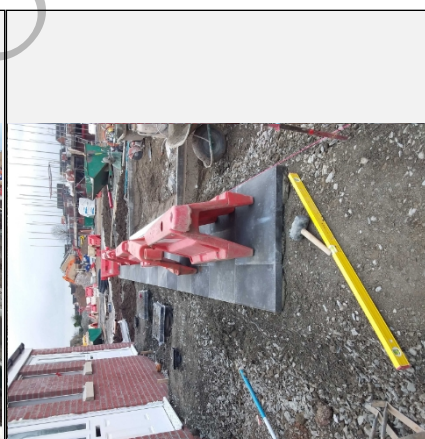
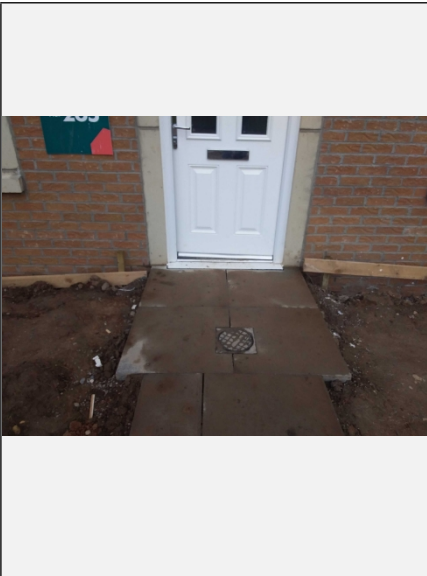
DESCRIPTION	SEVERITY	PLOTS AFFECTED
Access paths have been freshly laid to straight lines and were in the main flat with no trip hazards. Preventative measures have been taken to prevent footfall <b>Images: 1, 2, 3</b>	Industry Standard	Plot 260, Plot 263
Level access has been provided to the principle entrance with a 10mm gap <b>Images: 4</b>	Industry Standard	Plot 265

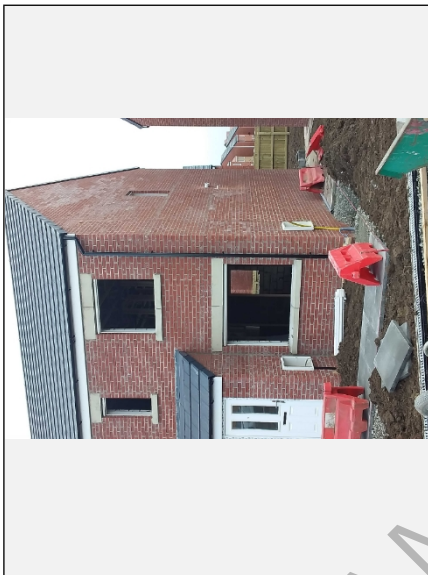
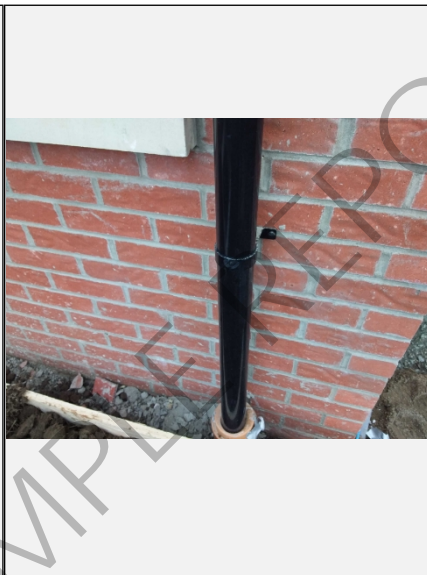
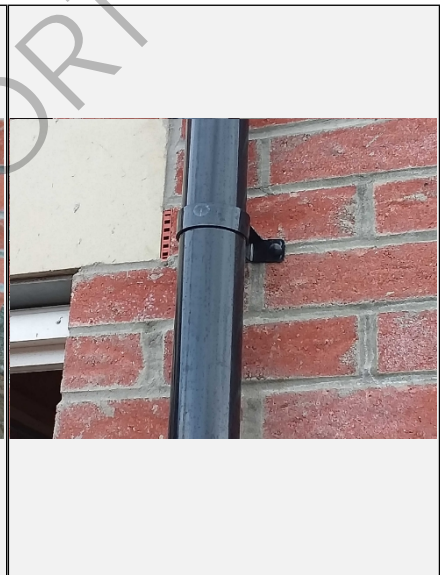
DESCRIPTION	SEVERITY	PLOTS AFFECTED
The rainwater pipes were fitted with the correct number of brackets, plumb and have screw caps <b>Images: 1, 2, 3</b>	Industry Standard	Plot 261

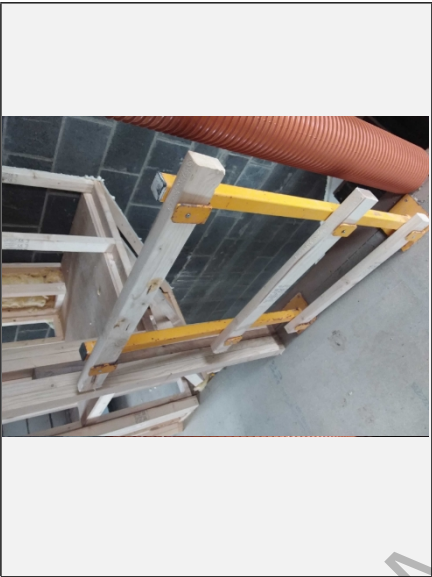
DESCRIPTION
Temporary guarding in place to prevent from falling <b>Images: 1</b>

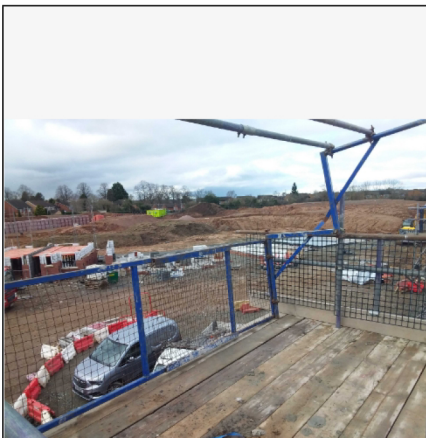
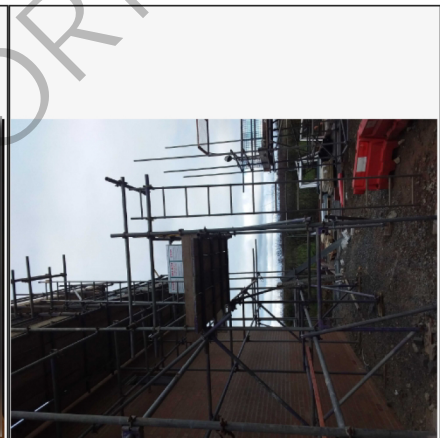
Scaffold check sheets have been completed. All ladders have been securely affixed to the scaffold and extend above the platforms 5 rungs/1m, kick boards, netting and loading bays with cages have been installed

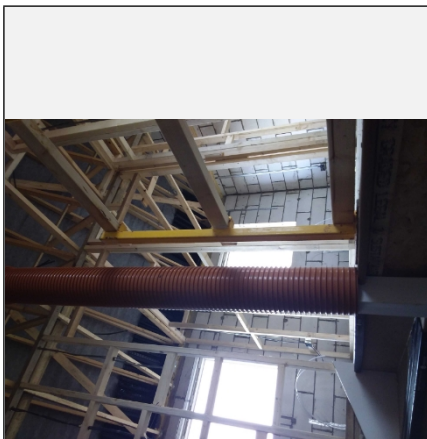
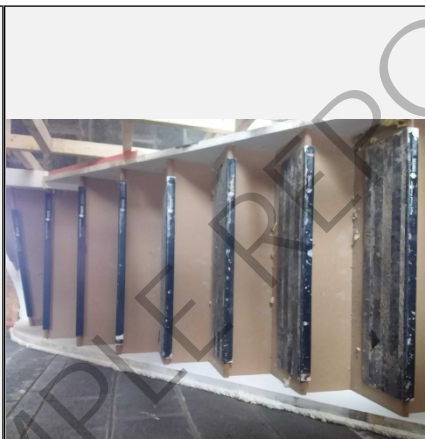
Good protection of staircase treads and newel post

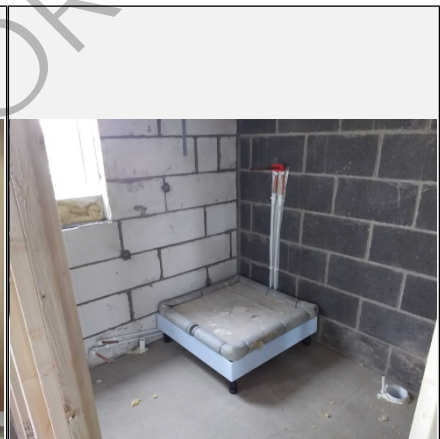
3)

Shower tray has been protected from following trades
