TIMBER WINDOWS: AVOIDING COMMON FAILURES – WATER INGRESS AROUND GLAZING

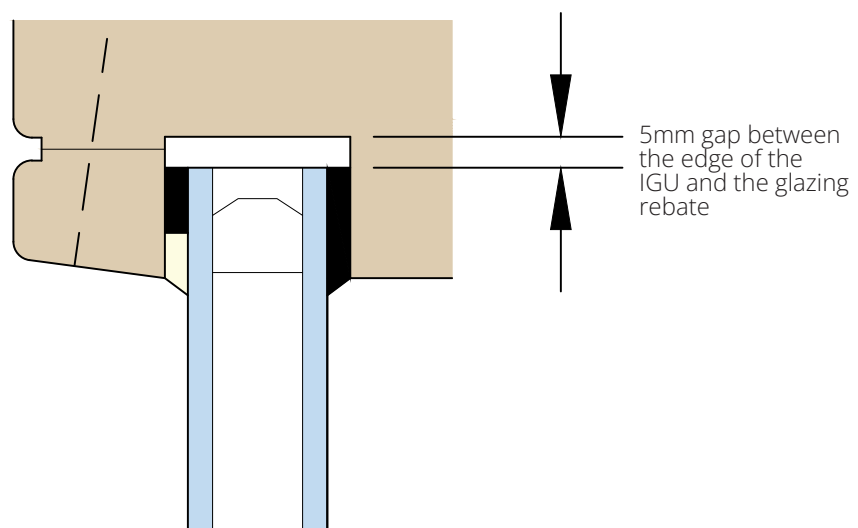
Section through head detail

No allowance for drainage

The IGU has been set too close or touching the rebates of the frame and inhibits the drainage of water. A 5mm drainage path between the edge of the IGU and the rebate should be provided all round the IGU perimeter as this space allows any water that does penetrate seals to run to the bottom of the glazed area where it can drain out.

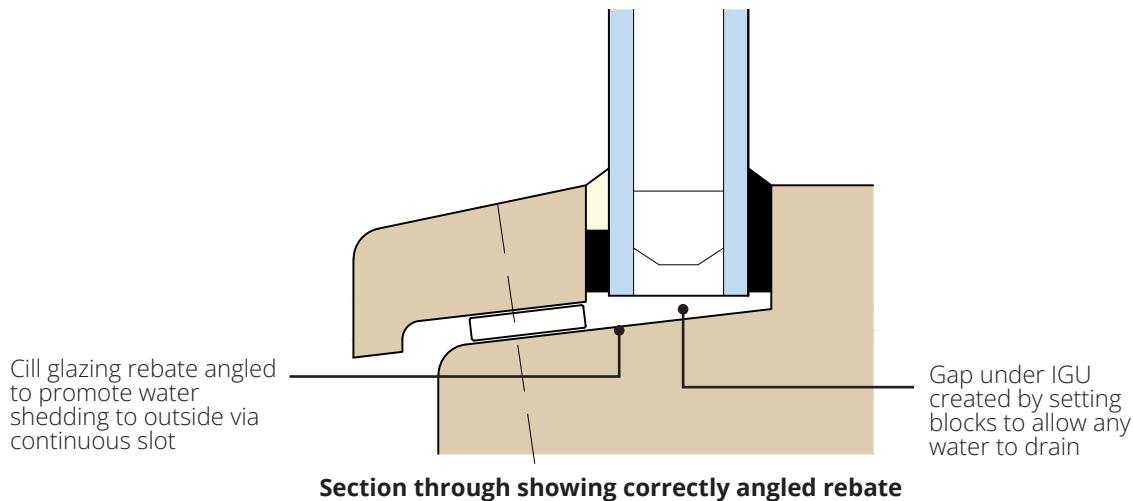
No setting blocks under the IGU

IGUs should be set into position using location and setting blocks. These blocks should be placed at intervals around the perimeter of the IGU. The spaces in between allow for any penetrating moisture to run to the bottom rebate and drain out.

The upper surface area of the cill rebate should be angled at a 1:10 (approximately 5.5° angle) so that any water driven into concealed spaces is directed out to the external face via a continuous drainage slot.

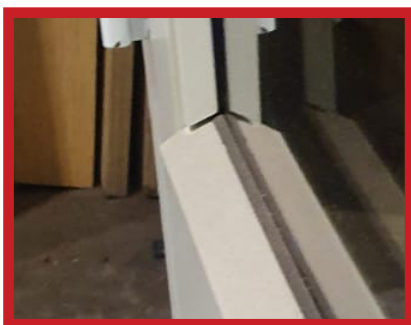
Jamb bead cut short, with bottom bead and seals connecting with glazing to ensure water cannot run in through bead joints

To ensure robust and sustained weatherproof details, glazing beads should not be mitred at joints but cut squarely. The top horizontal glazing bead should run the full width of the opening to protect the top of the jamb beads on either side and the wider bottom bead should also run the full width of the opening and project to conceal the drainage weep slot provisions below.

The side (jamb) beads should be cut to stop short of the bottom bead by 3mm – where the bottom bead has a 1:6 (11° angle) weathering slope on its top surface, the gap can be reduced at the glass face by cutting the ends of the side beads to a shallower pitch.

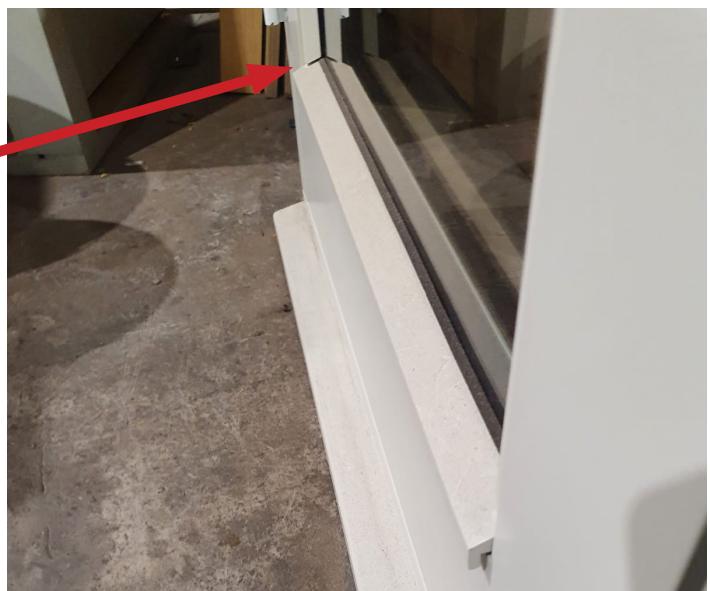
Image showing correctly scribed beading
