TIMBER WINDOWS: AVOIDING COMMON FAILURES – WATER INGRESS AROUND GLAZING

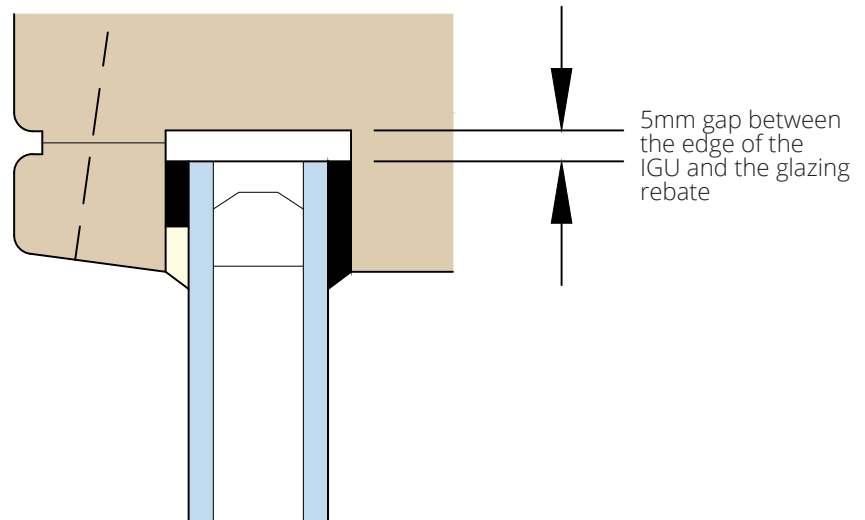
Section through head detail

No allowance for drainage

The IGU has been set too close or touching the rebates of the frame and inhibits the drainage of water. A 5mm drainage path between the edge of the IGU and the rebate should be provided all round the IGU perimeter as this space allows any water that does penetrate seals to run to the bottom of the glazed area where it can drain out.

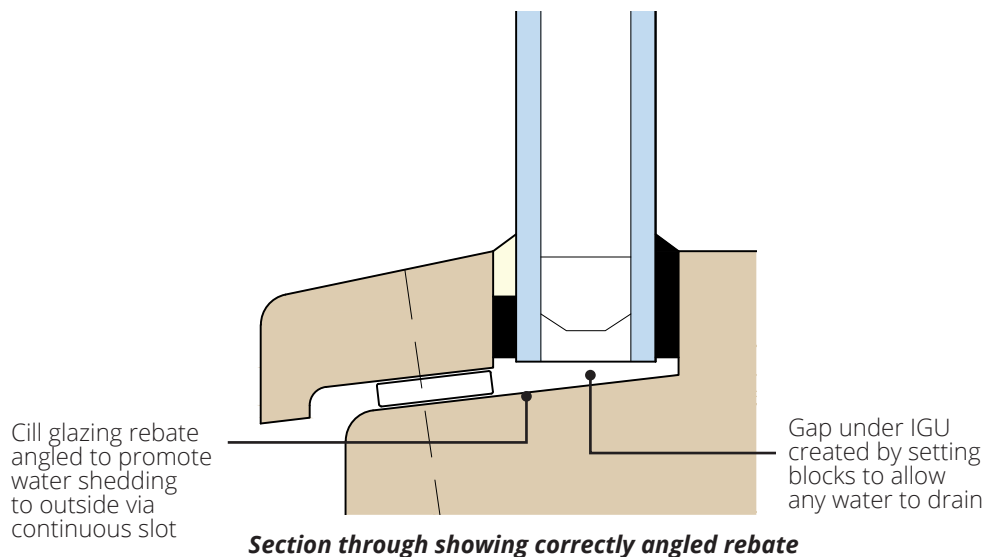
Section through showing correctly angled rebate

No setting blocks under the IGU

IGUs should be set into position using location and setting blocks. These blocks should be placed at intervals around the perimeter of the IGU. The spaces in between allow for any penetrating moisture to run to the bottom rebate and drain out.

The upper surface area of the sill rebate should be angled at a 1:10 (approximately 5.5° angle) so that any water driven into concealed spaces is directed out to the external face via a continuous drainage slot.

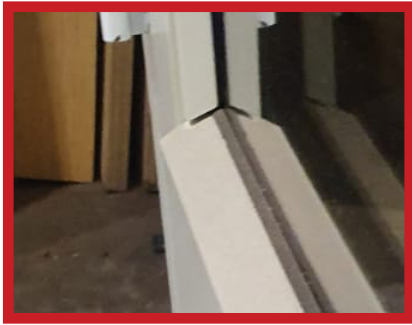
Image showing correctly scribed beading

Mitred beading often leads to joints opening in service giving a direct path to moisture at corners. At the junction of bottom bead and vertical beads, water penetrating this area either becomes trapped or is directed into concealed areas of the frame.

To ensure robust and sustained weatherproof details, glazing beads should not be mitred at joints but cut squarely. The top horizontal glazing bead should run the full width of the opening to protect the top of the jamb beads on either side and the wider bottom bead should also run the full width of the opening and project to conceal the drainage weep slot provisions below.

The side (jamb) beads should be cut to stop short of the bottom bead by 3mm – where the bottom bead has a 1:6 (11° angle) weathering slope on its top surface, the gap can be reduced at the glass face by cutting the ends of the side beads to a shallower pitch.

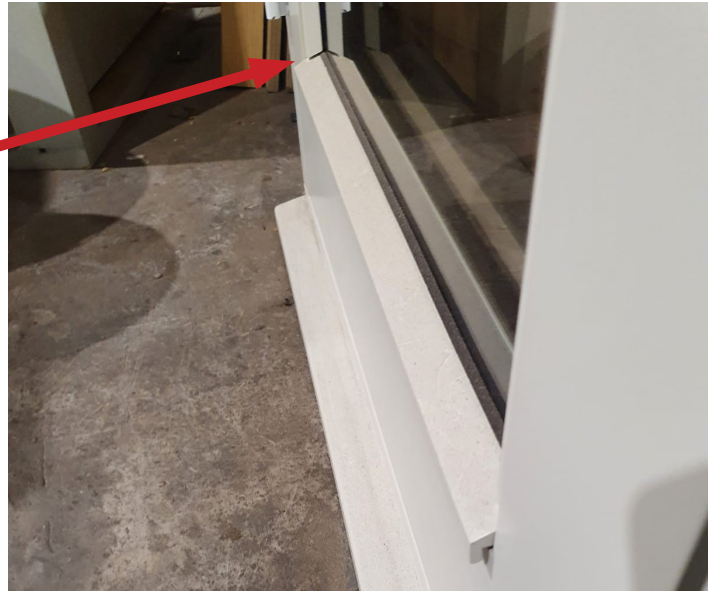
Jamb bead cut short, with bottom bead and seals connecting with glazing to ensure water cannot run in through bead joints

The glazing beads should be securely fixed with non-ferrous pins or screws at a 200mm maximum spacing, starting at 50mm from corners to create a compression seal between the bead and the glass surface.
