# TECHNICAL UPDATE

Timber windows – avoiding common failures  
Window assembly

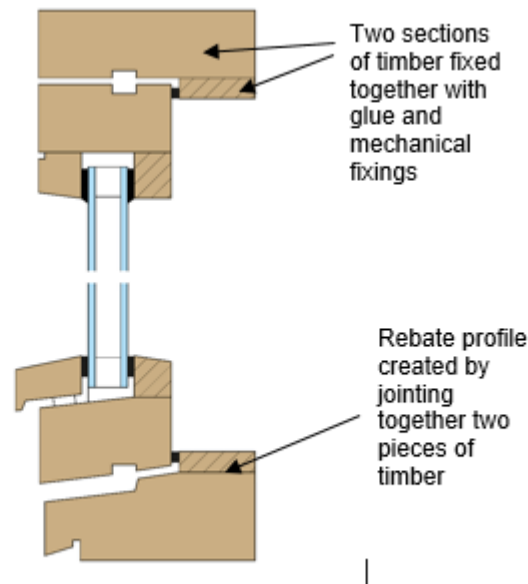
Frame created  
from separate  
sections of timber

The practice of ‘manufacturing’ timber frame sections in uncontrolled environments e.g. off-site in workshops not using the correct methodology and machinery, or ‘ad-hoc’ carpentry window ‘build-ups’ being created on-site, is resulting in timber window failures in service.

Investigations into these failures has revealed that the joints created between timbers are:

- Incorrectly positioned in relation to exposure to weather (generally considered as the first 40mm from the external face of the frame).
- Not formed in keeping with good carpentry practices or not bonded with adhesive - most are simply pinned or nailed into position. Even where adhesives have been used, they are often incorrect in their specification and do not perform as required.

As a result, any water collecting within the rebate section of the frame freely passes between timber sections and appears on the internal face of the timber frame as staining or as physical water deposits on window boards and adjacent surfaces.
