# HORIZONTAL CAVITY TRAYS OVER HORIZONTAL ROOF ABUTMENTS

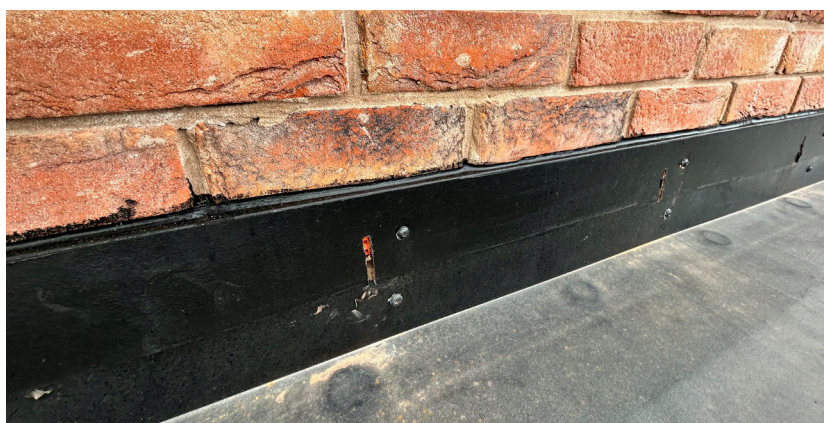
▲ Image 1

Image 1 shows an example of incorrect detailing at a roof abutment. During an inspection a defect was raised around the lack of 150mm to a roof upstand and incorrect positioning of the cavity tray. Upon returning, the Surveyor was presented with an extension of the upstand using a secondary flashing section with 'ad-hoc' slots cut to facilitate water expulsion from the walls cavity tray weepholes. It was not considered to be aligned with the acceptable approaches with the Technical Manual and deemed insufficient for the exacting standards set by Warranty.

Our stance is that the correct linking of the cavity tray with the horizontal cover flashing is critical, and that the cover flashing must sit directly underneath the cavity tray. Failure to provide this is considered to compromise the ability of the wall and roof construction in meeting with the Functional Requirements and Performance Standards stipulated by the Technical Manual, notably those relating to the avoidance of water ingress into the building.
