# SITE QUALITY REVIEW

**Garraby Mews, Victoria Way,  
Carlisle, CA2 5NP**

<b>Site Reference:</b>	PL-LABC-1959759
<b>Builder:</b>	Smith's Builders plc
<b>Developer:</b>	Rutland Homes Ltd
<b>Site Manager:</b>	John Smith

<b>Auditor:</b>	Mr Antal Poor
<b>Date of Inspection:</b>	02/03/2023
<b>Auditor Email:</b>	antal.poor@mdwis.co.uk
<b>Contact:</b>	07855548362

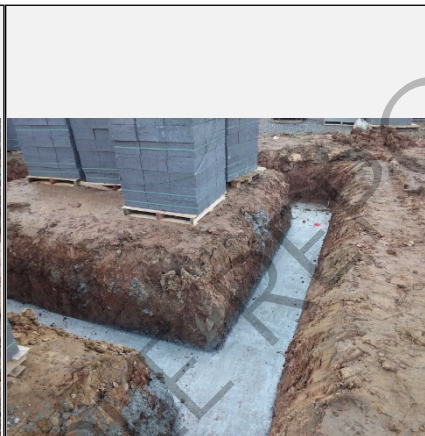
2) Plot 243 -

DESCRIPTION	SEVERITY	PLOTS AFFECTED
The strip foundations have been excavated and concreted prior to my inspection. The concrete was generally laid to straight lines and level <b>Images: 1, 2, 3, 4</b>	Industry Standard	Plot 243

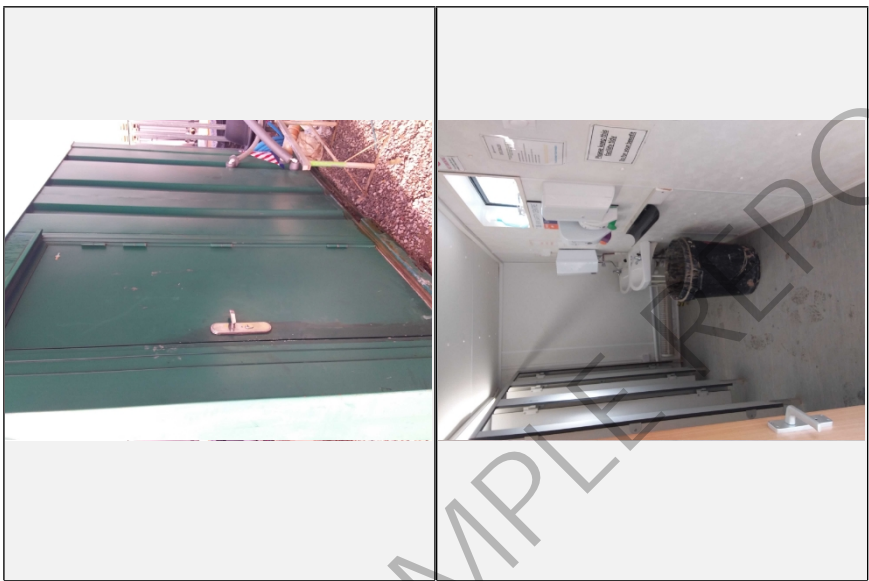
DESCRIPTION
A toilet block has been provided with a seperate lockable female facility <b>Images: 1, 2</b>

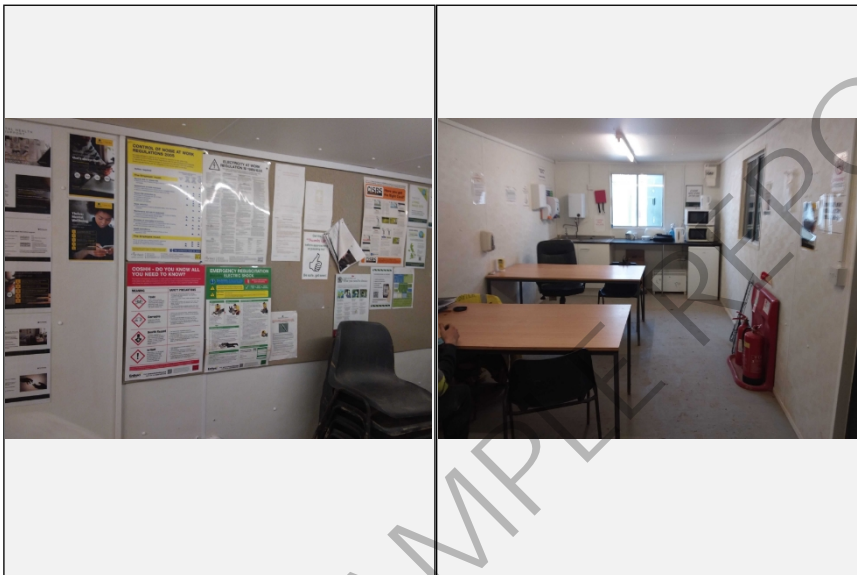
The rest room has the means to make a warm drink and heat food Long with a small refrigerator. A notice board displaying health and safety notifications and F10 notice is clearly visible within.

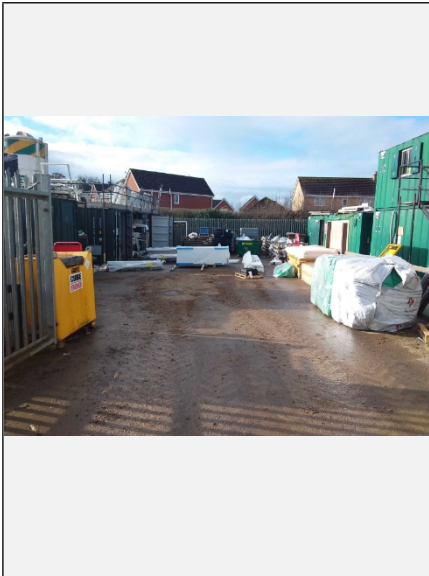
4)

The site compound is generally organised

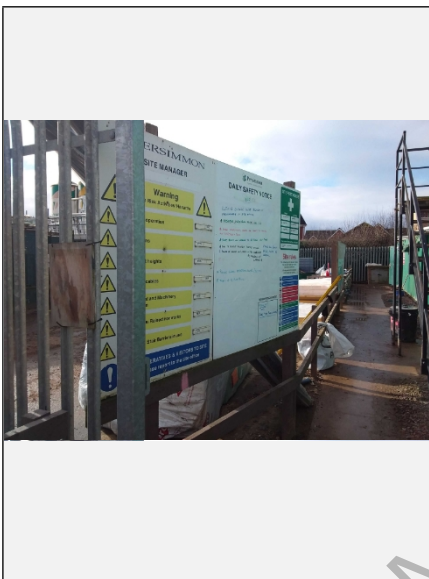
1)

A daily hazard board is visible upon entry to the site compound and has been updated stating the risk areas

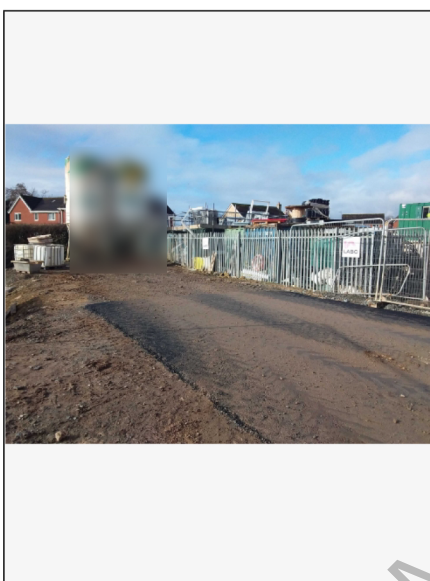
1)

A separate area next to the site compound has been provided for ease of access to the silos
